# **Strengthening of Bridge Columns Subjected to an Impact Lateral Load Caused by Vehicle Collision**

## **Phase I Final Report**

**PI: Azadeh Parvin, D.Sc.  
Associate Professor  
Department of Civil Engineering  
College of Engineering**

**August 2011**

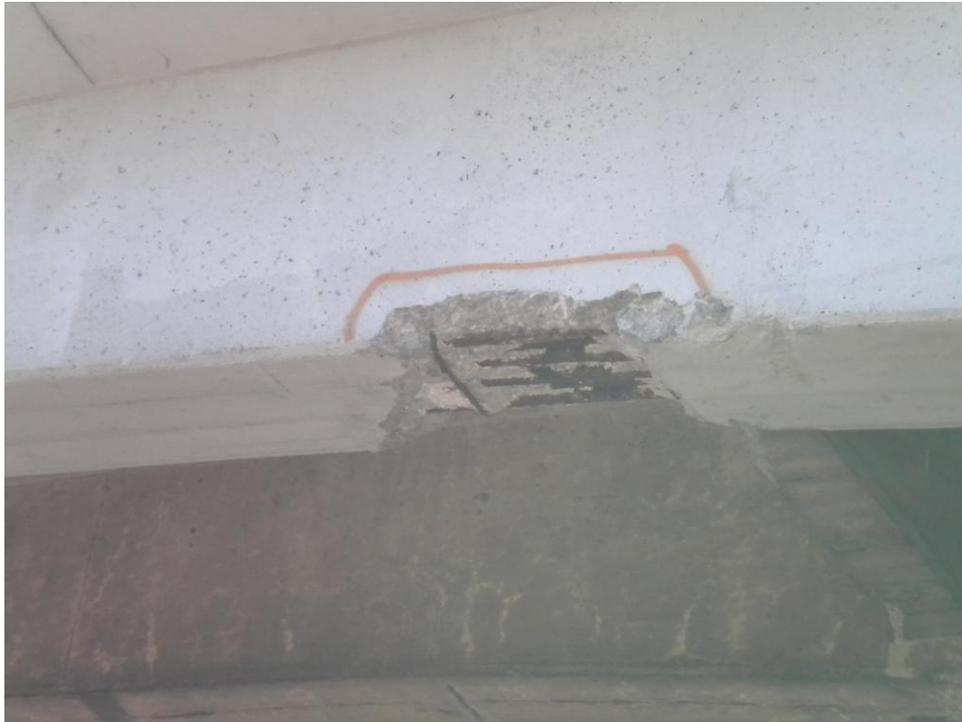
from vehicular collision damage. The damage caused by such impacts can lead to concrete cover spalling or cracking, reinforcement damage or exposure, or in worst cases, structural failure. Fig. 1 shows damage caused by an overheight vehicle striking a bridge girder.

**Fig. 1.** Damage Caused by Overheight Vehicle Collision
